NASA Technical Memorandum 110204

# **Structural Test Documentation and Results for the McDonnell Douglas All-Composite Wing Stub Box**

**Dawn C. Jegley and Harold G. Bush**  
*Langley Research Center, Hampton, Virginia*

**April 1997**

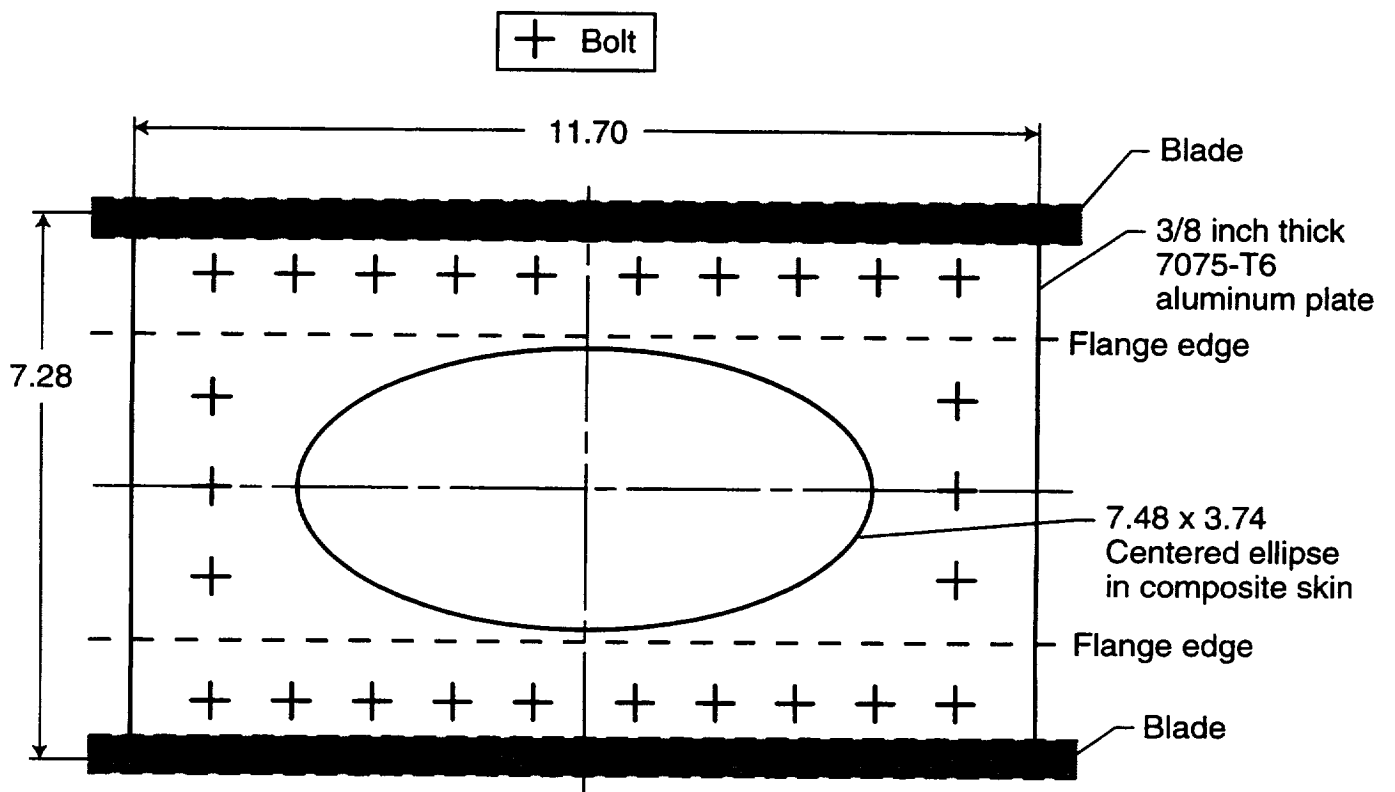
Figure 22. Repair configuration. All dimensions are in inches.

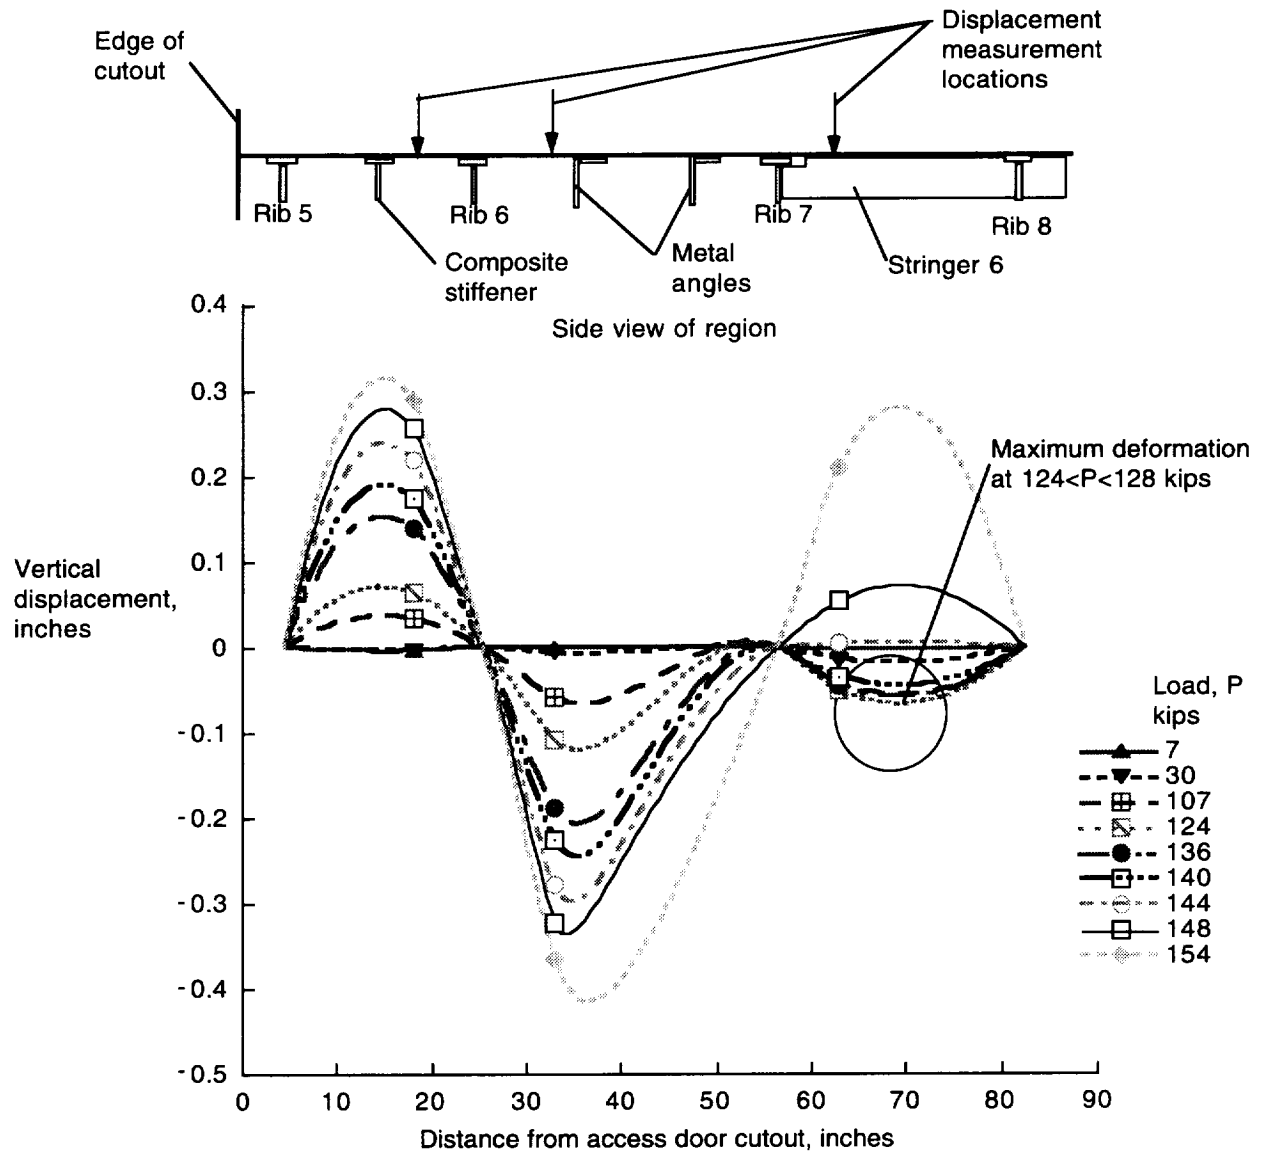
Ribs 5, 6, 7, and 8 support the cover panel outboard of the access-door cutout. By assuming that there is no difference between deformations in the unsupported region and the far field results at the locations of these ribs, and by considering the difference between displacement measurements in the unsupported region and the far field region, deformations caused by local behavior outboard of the access-door cutout edge to rib 8 can be determined. This deformation pattern is shown in figure 29 for a series of load levels. Measured differences are shown as symbols in figure. The curves shown in the figure are interpolations used to connect the assumed rib displacements and the measured data. Between ribs 5 and 6, the displacement increases monotonically as the load increases from zero to the maximum load. The location of the maximum displacement in this bay is half way between the ribs and the magnitude of the maximum displacement is approximately 0.33 inches. The skin deforms upward out of the wing stub box. Between ribs 6 and 7, the magnitude of the displacement also increases monotonically as the load increases from zero to the maximum load, however, the location of the maximum displacement is not half way between the ribs but is dependent upon the load level. The maximum displacement is 0.42 inches downward into the wing stub box between ribs 6 and 7. Between ribs 7 and 8, the magnitude of the displacement increases monotonically as the load increases from zero to 120 kips. However, the displacement reaches a maximum value of 0.07 inches downward into the wing stub box at a load of approximately 126 kips, then decreases in magnitude and changes sign at a load of approximately 144 kips. This reversal of direction of the displacement indicates that a change in the behavior of the upper cover panel skin has occurred. Nevertheless, the location of the maximum displacement in this bay is half way between the ribs for each load level whether the displacement is up or down. The maximum displacement between ribs 7 and 8 when the structure failed was 0.28 inches.

Figure 29. Relative vertical displacements outboard of access door cutout.

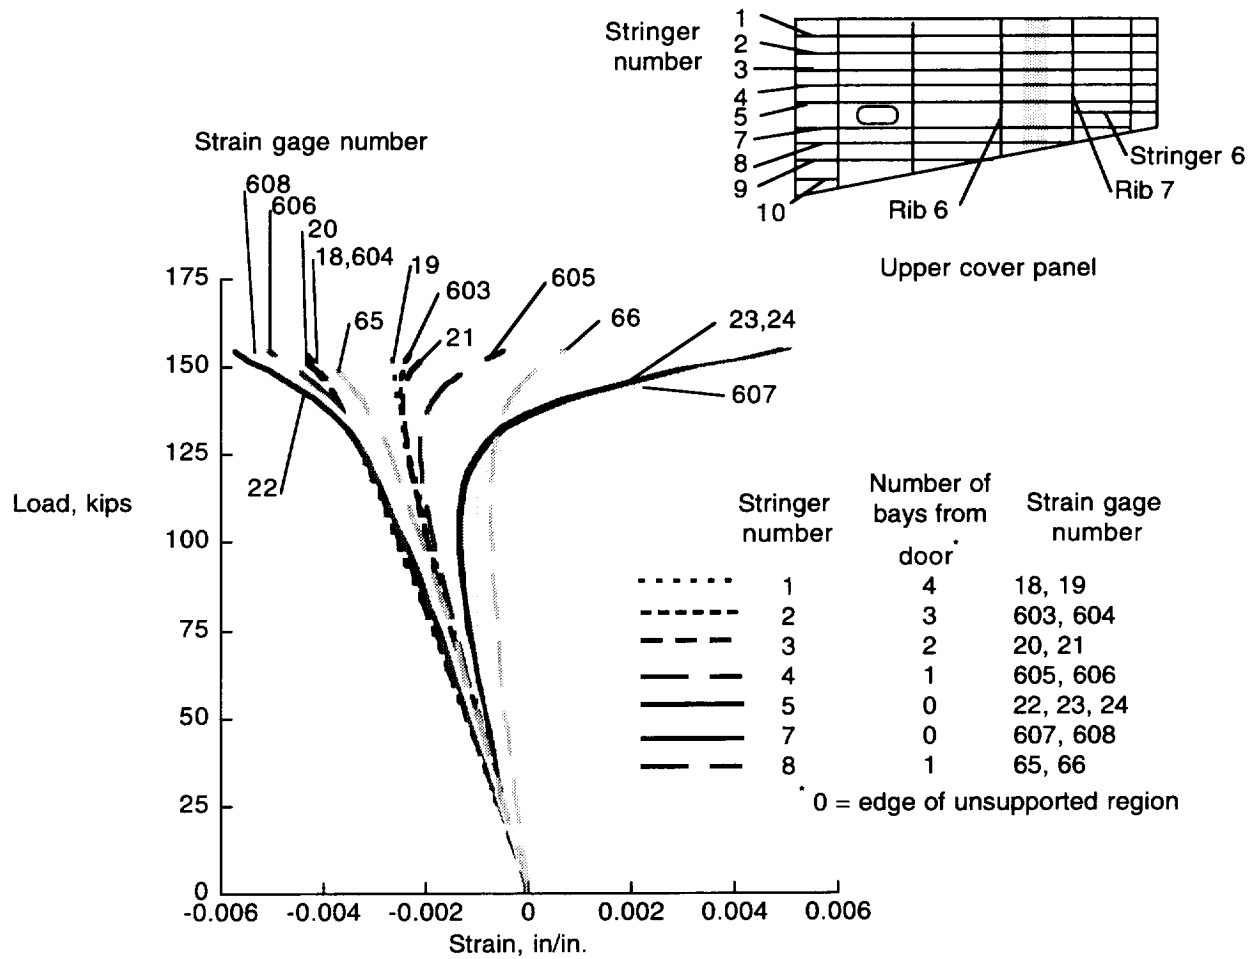
The strains measured between ribs 6 and 7 are shown in figure 31. The solid lines represent strains from strain gages 22, 23, 24, 607 and 608, which are on the stringer blades and skin at the edge of the unsupported region. The dashed lines represent strains from strain gages which are farther away from the unsupported region. Results from strain gages 23, 24 and 607, which are on the blades on the edge of the unsupported region, indicate the onset of nonlinear behavior at a load of approximately 100 kips and indicate pronounced nonlinear behavior starting at approximately 125 kips. Results from strain gages 18 and 19, which are the farthest from the unsupported region in this row, indicate nonlinear behavior away from the unsupported regions begins at a load of approximately 130 kips.

Figure 31. Strains for stringers in upper cover panel between ribs 6 and 7.

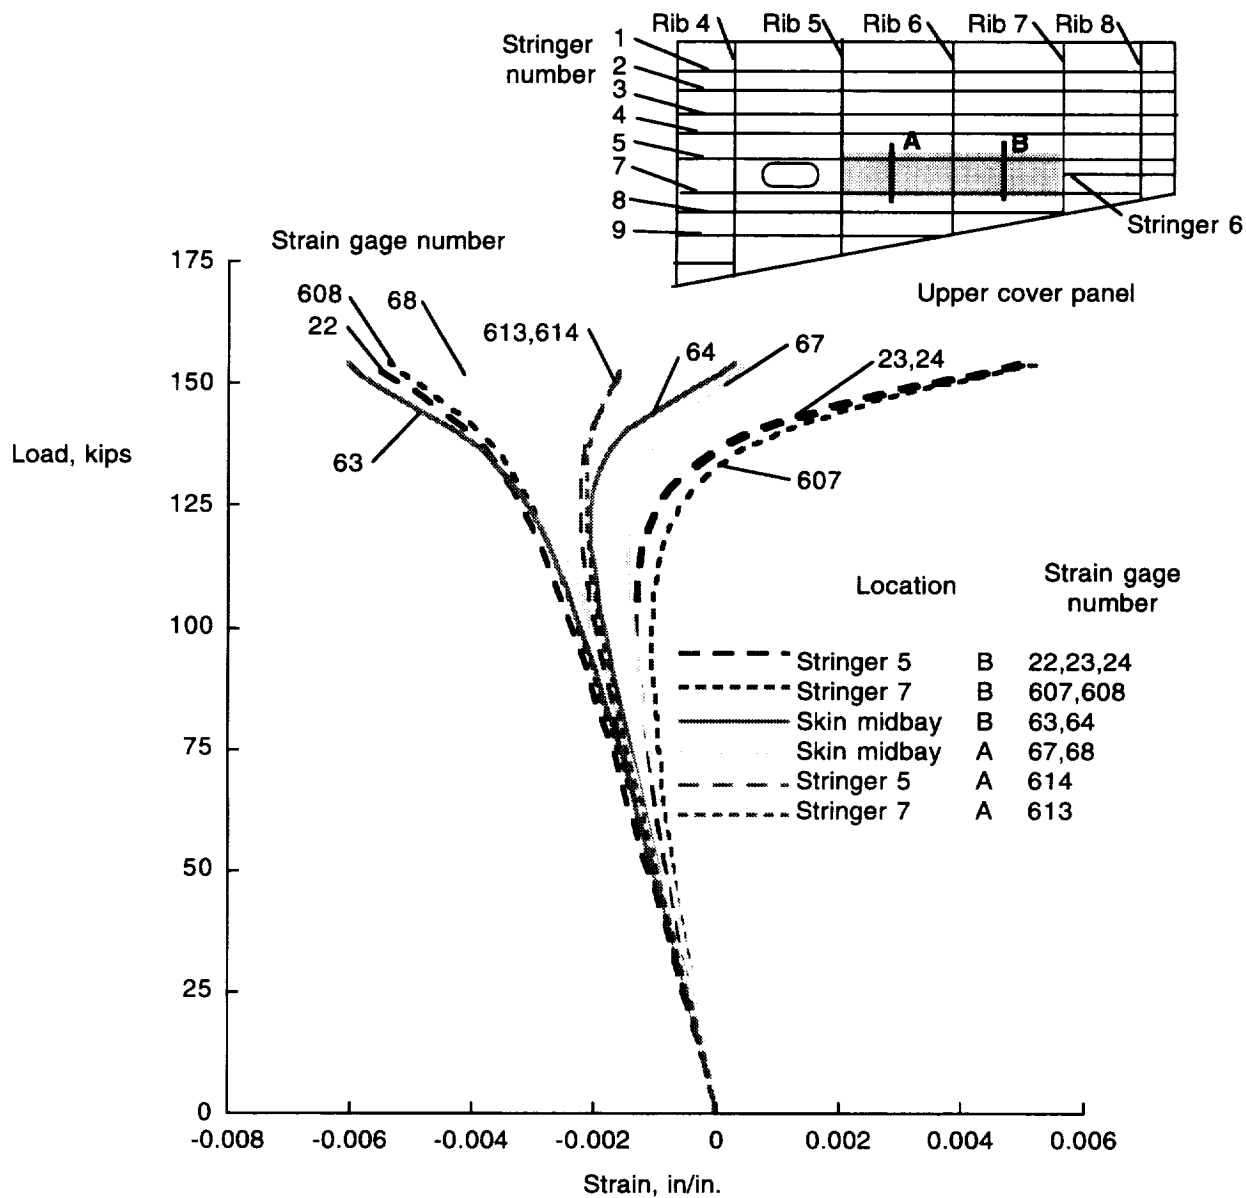
The strains measured in the unsupported skin between ribs 5 and 7 and in adjacent stringers 5 and 7 are shown in figure 34. Location "A" in the figure is half way between ribs 5 and 6. Location "B" in the figure is half way between ribs 6 and 7. The results from strain gages on the skin are shown as solid lines while the results from strain gage at the stringers are shown as dashed lines. All strain results in this region indicate nonlinear behavior. The most pronounced nonlinearity can be seen in the results from interior strain gages 23, 24 and 607, which are on the stringers surrounding the unsupported skin between ribs 6 and 7. Comparison of results from back-to-back strain gages 63 and 64, which are on the skin between ribs 6 and 7, suggest that an instability initiates at approximately 135 kips. Nonlinear behavior initiates prior to that load level. Similarly, results from strain gages 67 and 68, which are between

Figure 34. Strains in and around unsupported skin region between ribs 5 and 7.

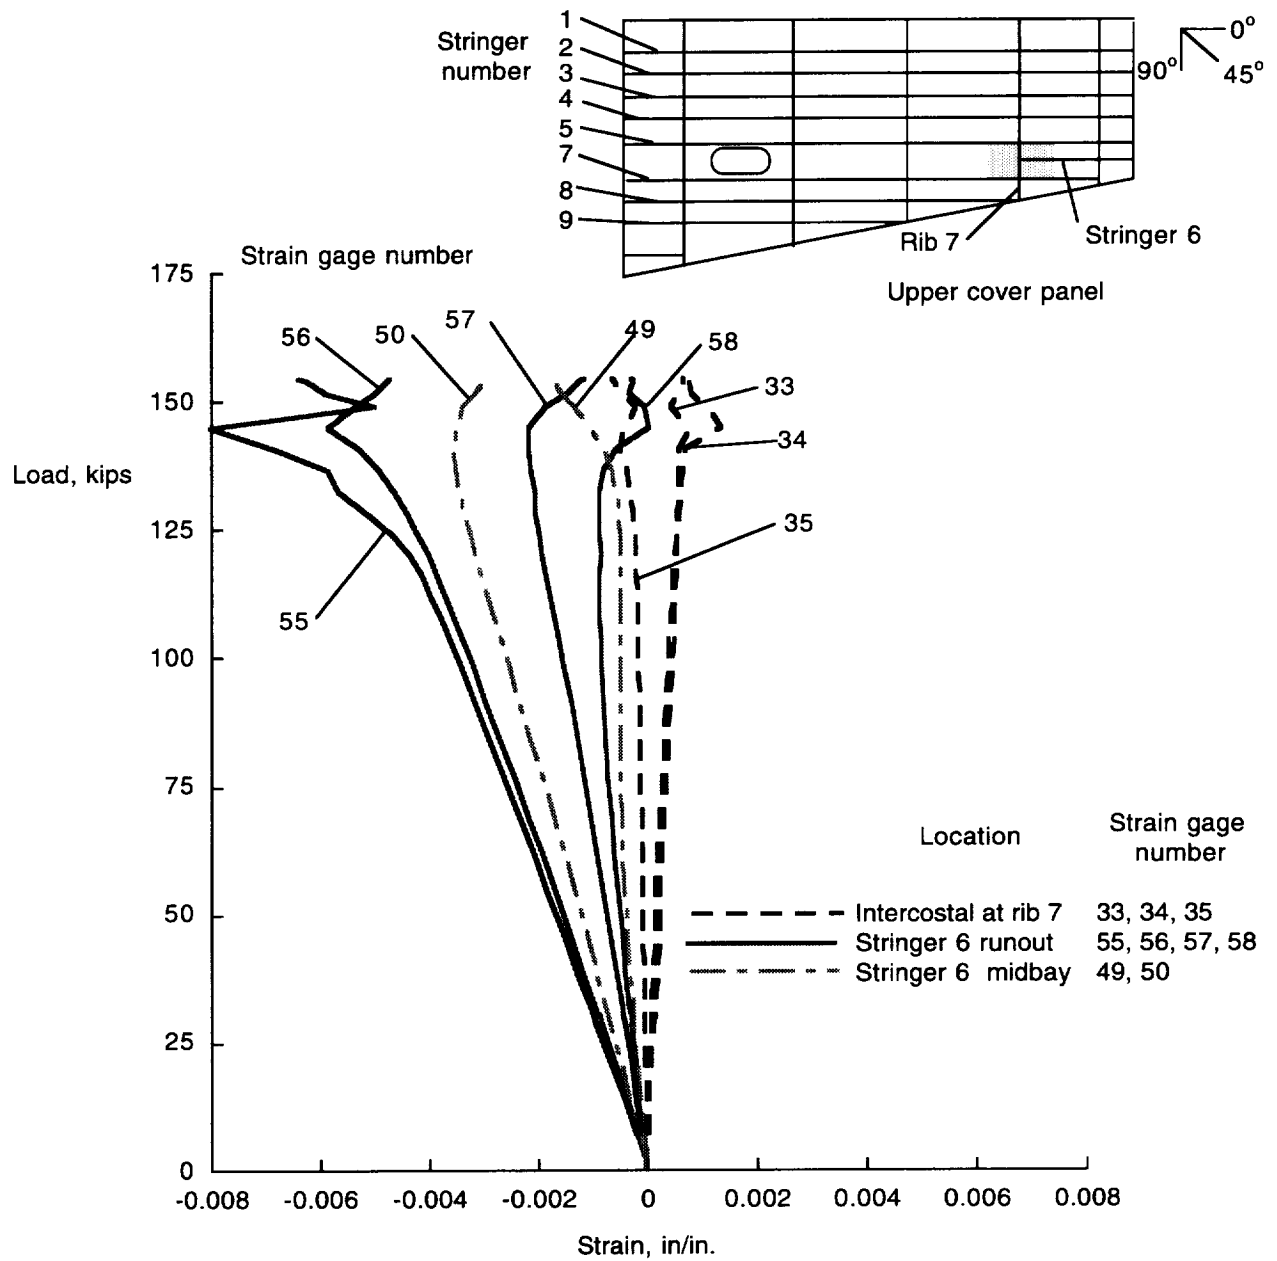
The strains measured on the runout of stringer 6 and at the intercostal at the intersection of rib 7 and stringer 6 are shown in figure 35. All strain gages are oriented axially except for strain gage 34, which is oriented 45 degrees to the stringers, and for strain gage 35, which is oriented 90 degrees to the stringers. All strain gage results indicate linear behavior with no pronounced discontinuities in slope for loads less than 120 kips. Nonlinearity in the load-strain behavior in the runout at stringer 6, indicated by strain gages 55, 56 and 58, begins at a load of approximately 120 kips. Nonlinear behavior initiates between 130 and 140 kips for strain gages 57, 35, 49 and 50. A strain reversal occurs at a load of 140 to 145 kips at strain gages 33, 34, and 35 on the intercostal at rib 7 and at strain gages 55, 56, 57, and 58 on the stringer at the runout. This reversal also occurs on stringer 6 away from the runout at strain gages 49 and 50, though no pronounced discontinuities in slope occur at strain gages 49 and 50. Discontinuities in slope occur in strain gages 55, 56, 57, and 58 at 145 kips. Discontinuities in slope occur at strain gages 33 and 34 at 140 kips, 145 kips and at 150 kips. A series of local failures would explain this behavior.

Figure 35. Strains for stringer 6 runout and intercostal at rib 7.

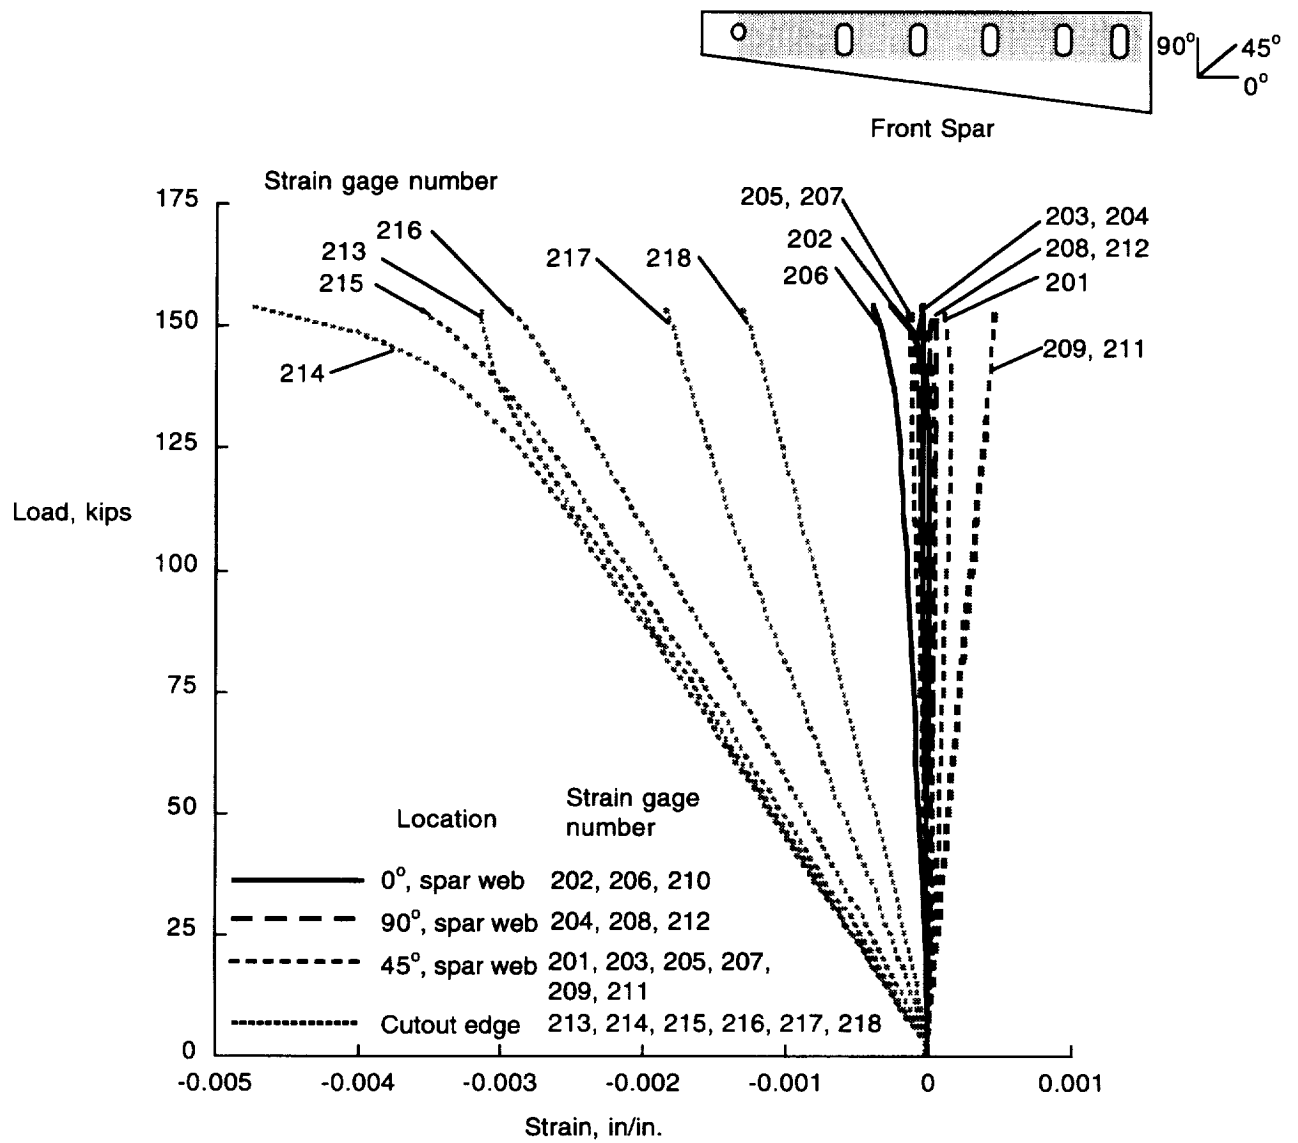
Figure 48. Strains for front spar.

Strain gage results for the front and rear spars are shown in figures 48 and 49, respectively, for strain gages positioned in midbay locations and on the cutout edges. Results for axial midbay strain gages are shown in the figure as solid curves. Results for strain gages oriented 90 degrees to the upper cover panel (out-of-plane to the cover panels), oriented at a 45 degree angle to the upper cover panel, and at the cutout edges are shown as dashed curves. The plots of strains in the front and rear spars are shown to the same scale. Strains measured on the front spar are linear for the entire load range except for strain gages 213, 214, 215 and 216. These four strain gages have a linear behavior for loads less than approximately 120 kips, then have a nonlinear behavior. They are located on the upper edges of cutouts in the front spar, with the more outboard strain gages recording the higher strains. The

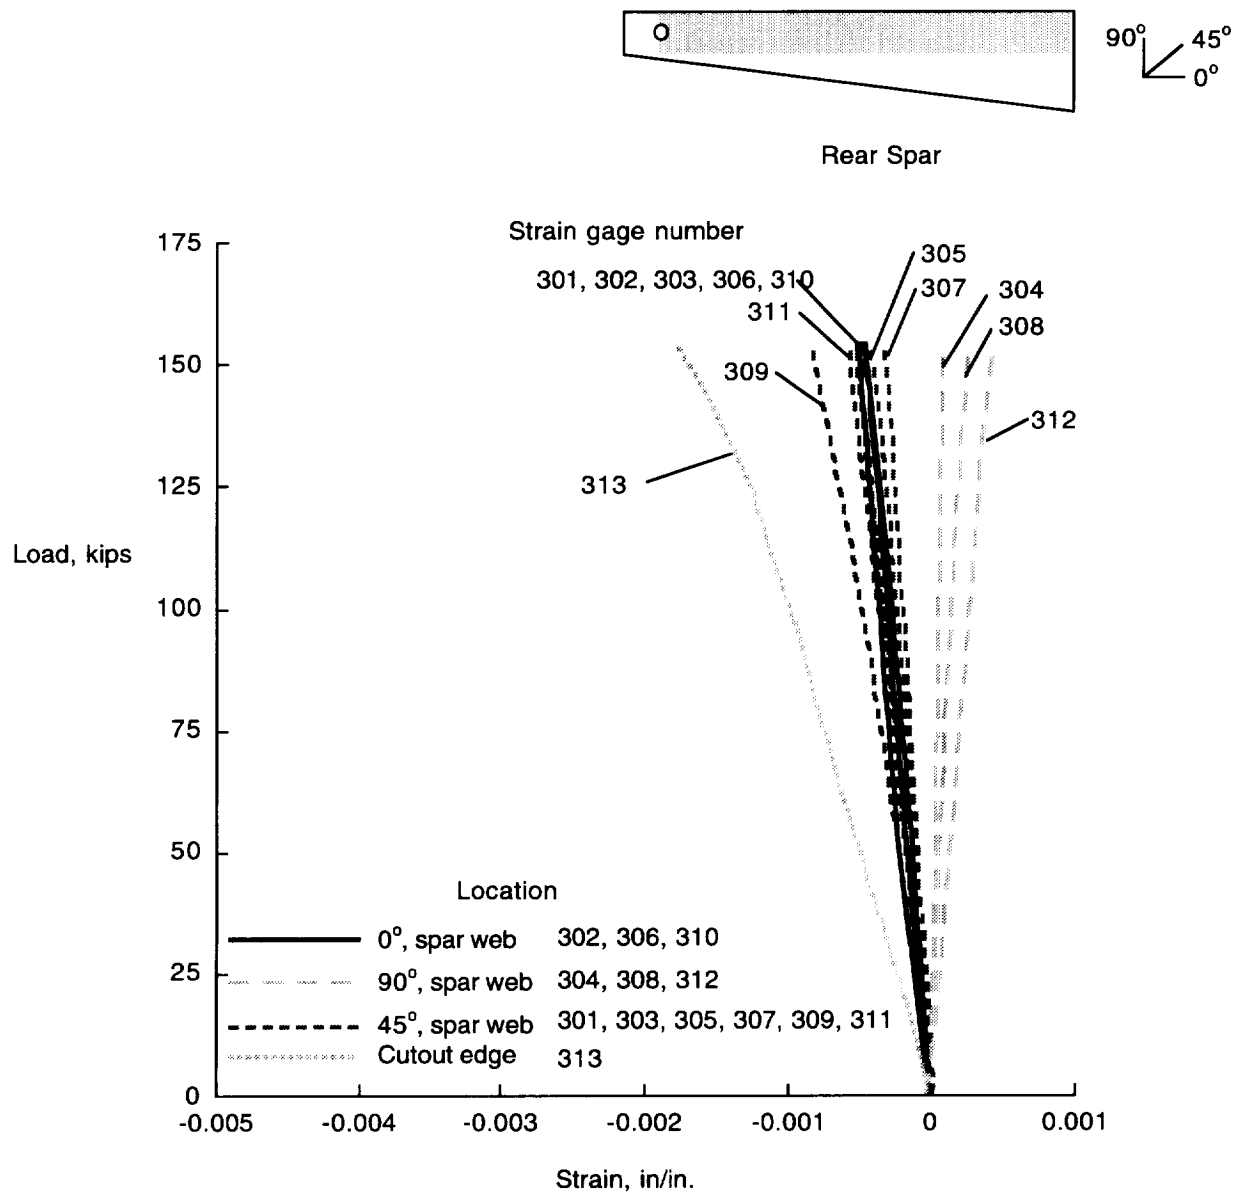
Figure 49. Strain in rear spar.

Only strain gage 313 on the rear spar recorded nonlinear strains, as shown in figure 49. There was one cutout in the rear spar and strain gage 313 was located on the upper edge of that cutout. No strains with magnitudes greater than 0.002 in/in. were recorded on the rear spar.

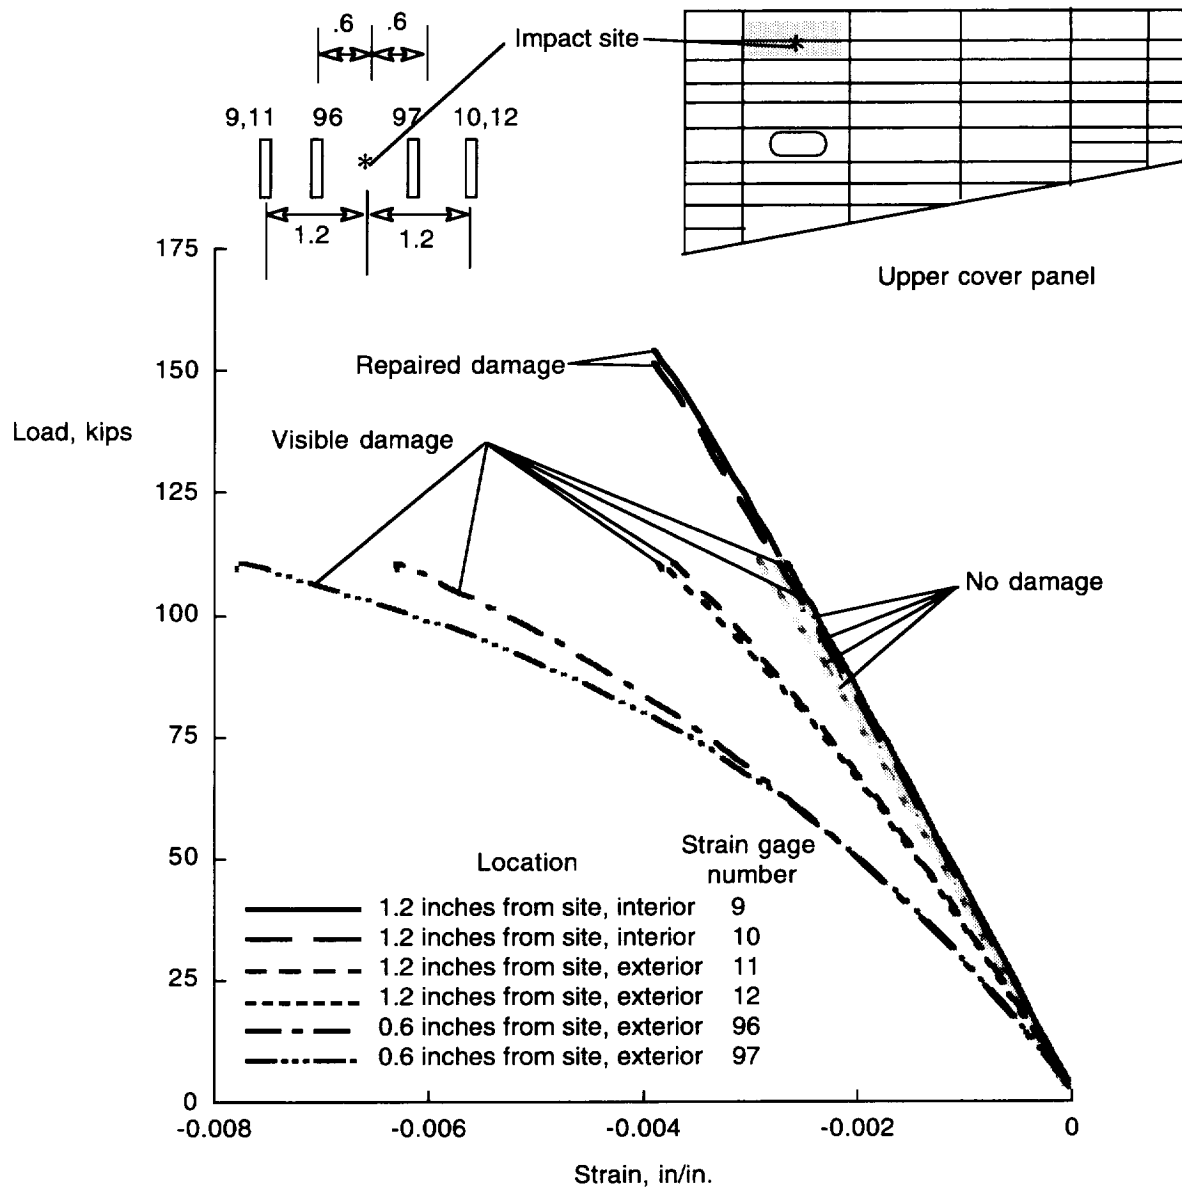
Figure 57. Strains in detectable-damage and repair region during last three tests. All dimensions are in inches.

The strains in the impact-damaged regions are presented in figures 57-61. The strains recorded for the upper cover panel skin in the region of detectable impact damage during three tests of the structure are shown in figure 57. Results are shown for the structure loaded to DLL prior to inflicting damage, the structure loaded to DLL after inflicting damage and the structure loaded to failure after the repair was installed. The strains for the skin and the repair for the final test only are shown in figure 58.

During the loading prior to inflicting damage, the strains in the skin are linear and reach a maximum magnitude of approximately 0.003 in/in. All strain gages in the region to be repaired recorded approximately the same strain. In the loading after visible damage was inflicted, the strains in the skin closest to the damage site were nonlinear in behavior for the entire load range. The maximum strain recorded in the region of visible impact damage is approximately 0.0073 in/in. in a strain gage which is 0.6 inches away from the impact site (strain gage 97). Interior strain gages 1.2 inches away from the impact site (strain gages 9 and 10) recorded the same strains with and without impact damage and with repair. The repair of the structure required the removal of the exterior strain gages closest to the impact site (strain gages 11, 12, 96 and 97). Axial strains measured during the final loading in the repaired bay and the bay adjacent to the repaired bay are shown in figure 58. Strain gages 5, 8, 9 and 10 on the skin recorded approximately the same strain. Strains recorded in the metallic repair are less than half the strains recorded

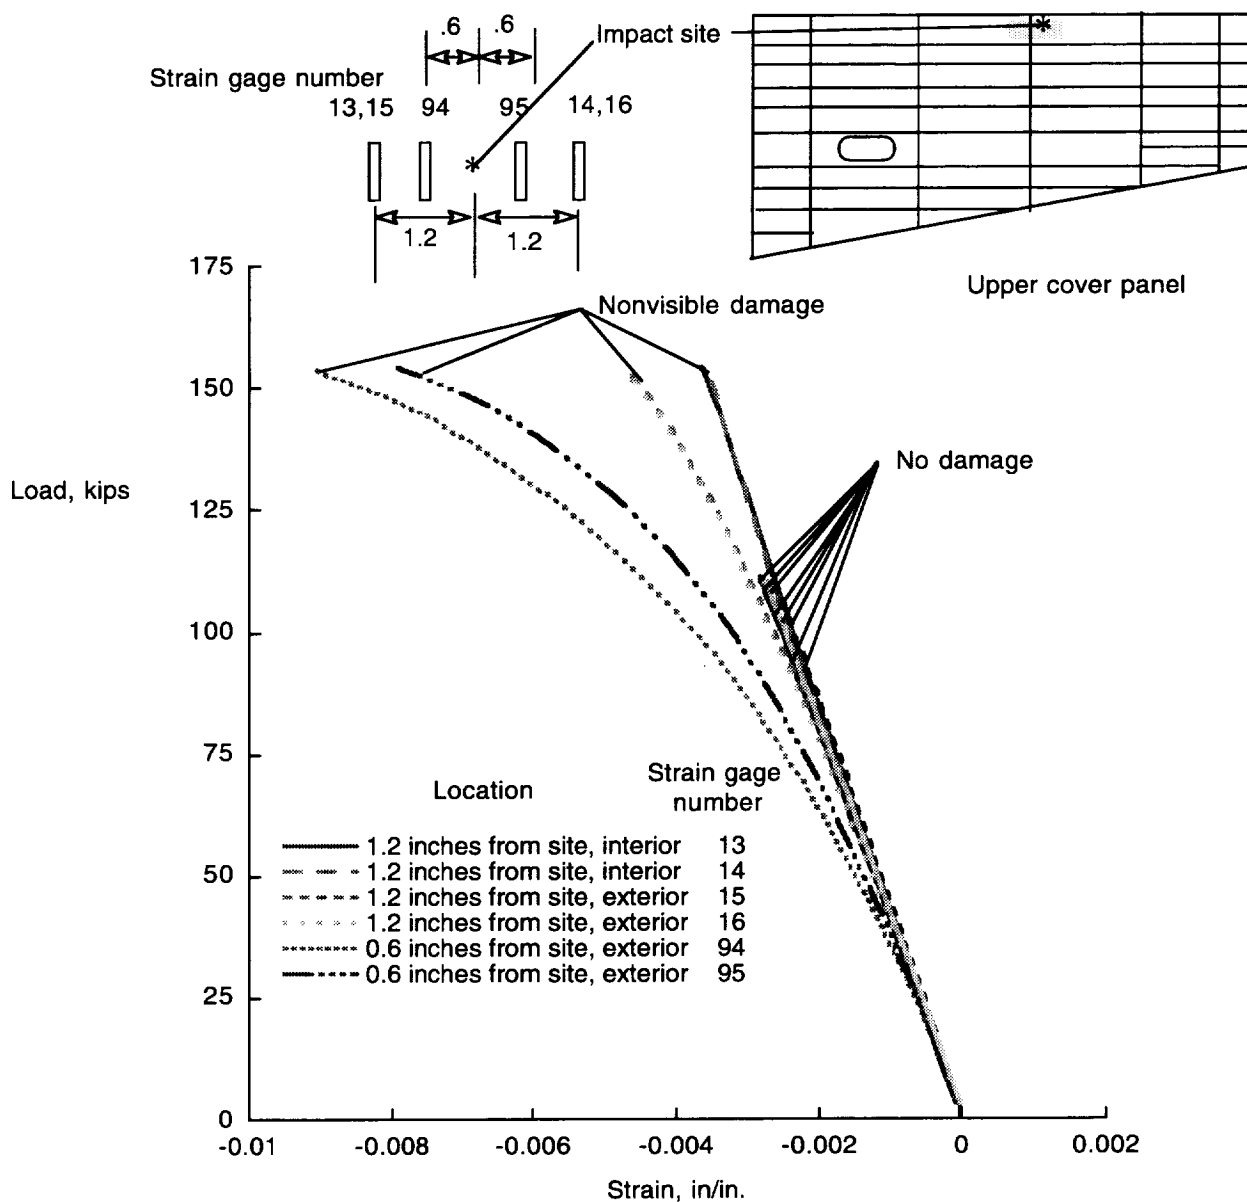
Figure 59. Strains at nonvisible damage site 1 for last three tests. All dimensions are in inches.

Two locations on the upper cover panel were subjected to nonvisible impact damage prior to the final test. The strains recorded during the last three tests near the location labeled NDT1 in figure 5 are shown in figure 59 and the strains around the location labeled NDT2 in figure 5 are shown in figures 60 and 61. Impact site NDT1 is located at the edge of an intercostal flange half way between the rear spar and stringer 1. Strain gages 13, 14, 15 and 16 are located 1.2 inches from impact site NDT1 and strain gages 94 and 95 are located 0.6 inches from site NDT1. Prior to impact, the strains 1.2 inches from NDT1 are linear and all strain gages recorded approximately the same values. The strain 1.2 inches from NDT1 at DLL is -0.003 in/in. After impact, the strains on the interior surface of the skin 1.2 inches from the NDT1 show the same linear behavior as they did prior to impact and remain linear to failure. A small amount of nonlinearity can be seen in the exterior strain gages 1.2 inches from the impact site and significant nonlinearity can be seen 0.6 inches from the impact site. At the maximum load of 154 kips, the largest compressive strain recorded in this region is -0.009 in/in. There were no failures detected in this region, and post-test evaluation of the site indicated no growth in the size of the damaged skin region.

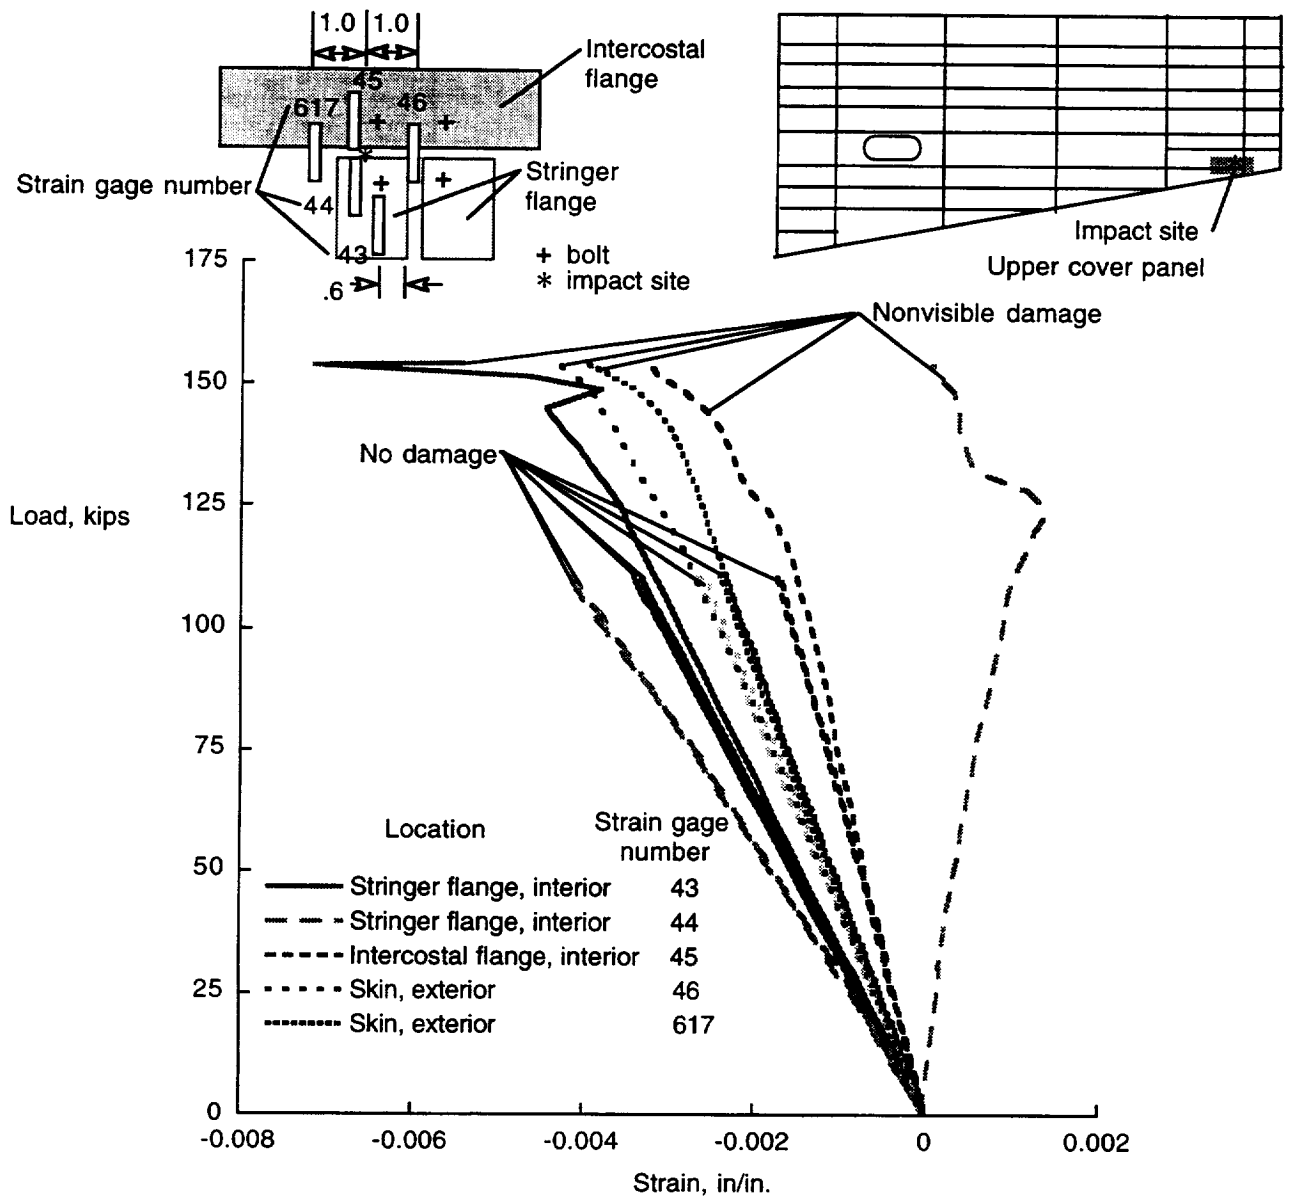
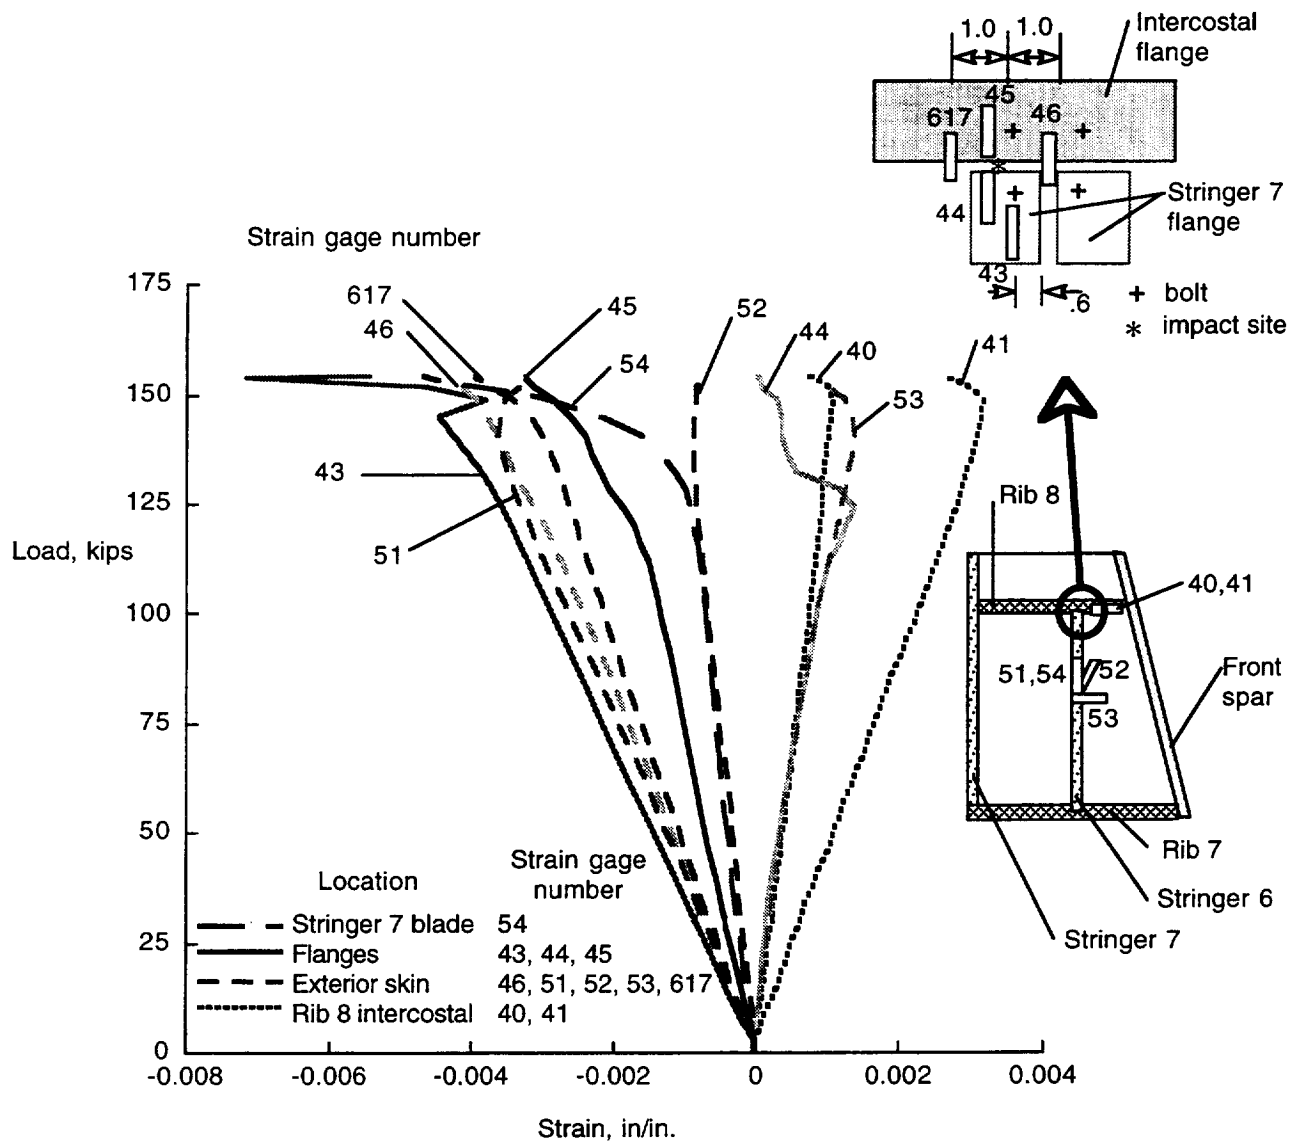
Impact site NDT2 is located at the edge of an intercostal flange and at the edge of the flange of a stringer runout. Strain gages were placed on the skin, on the stringer, and on the intercostal. Results from strain gages on the skin, the intercostal flange and the stringer flange for the last three tests are shown in figure 60. Results from these strain gages and from strain gages farther away from the impact site on the intercostal and on the stringer runout for the last test are shown in figure 61. The most obvious difference between the strains for the last test and the strains for the previous tests is in strain gage 44. Strain gage 44 is located on the stringer flange slightly inboard of the impact site. During the first tests this location was in compression. During the last test, this location was in tension. However, strain gages on the external surface (strain gages 46 and 617) are in compression for all of the tests. The most likely explanation for this difference is that the impact caused separation between the skin and stringer flange, allowing the stringer flange and skin to deform independently at that location. At a short distance from the impact site

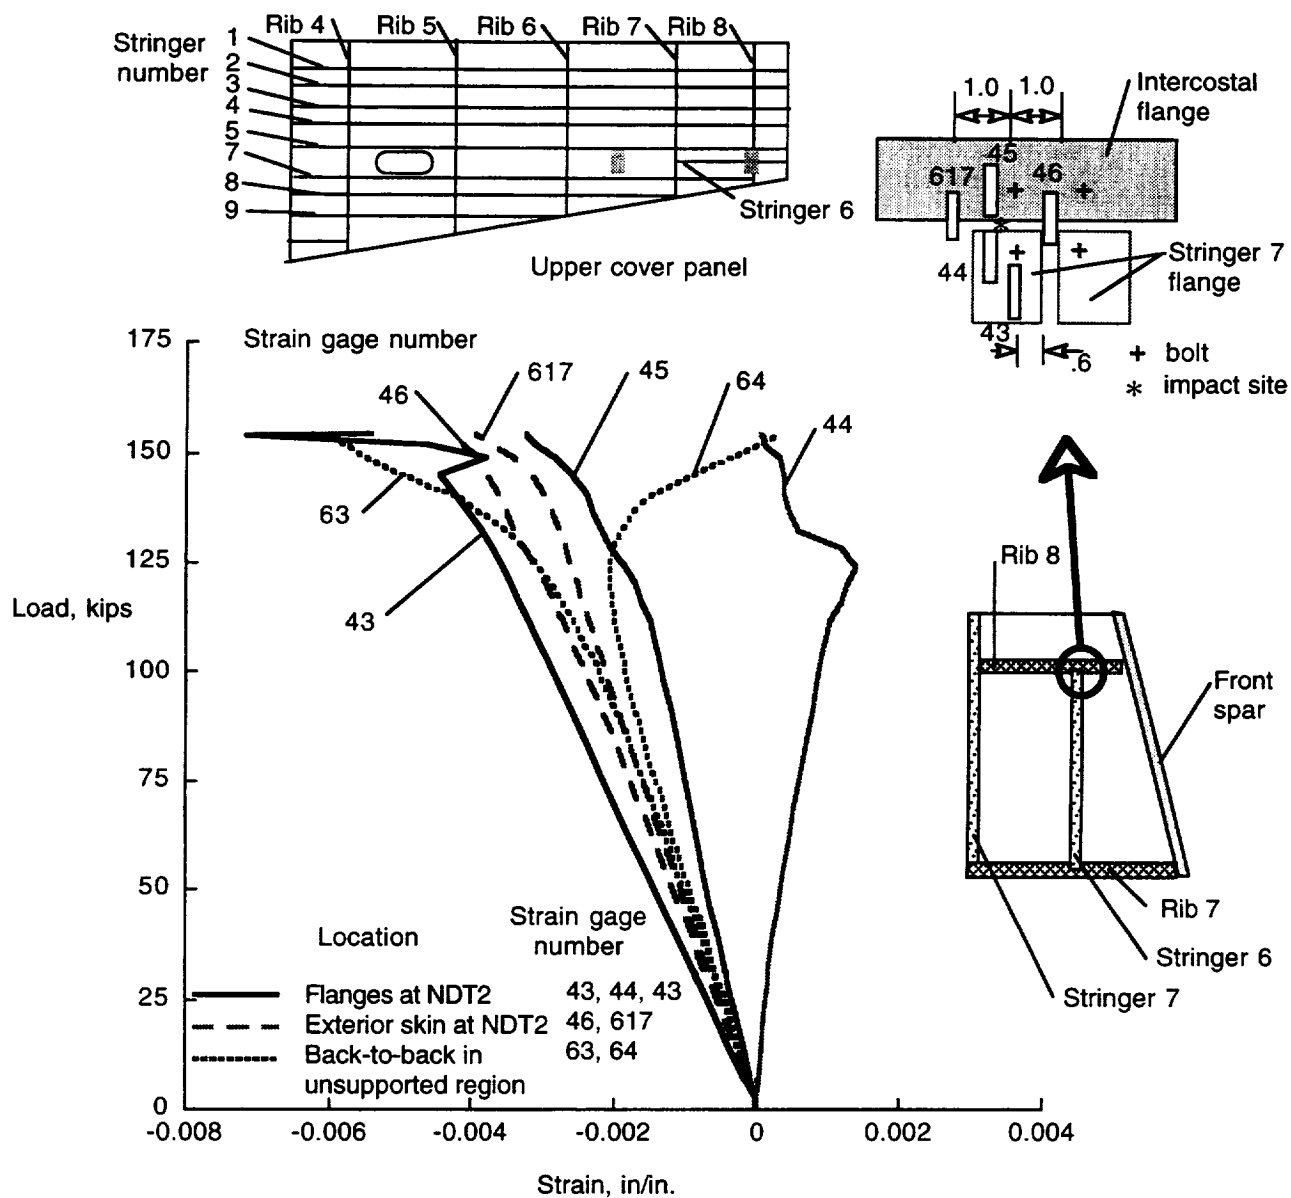
Figure 62. Strains in region of nondetectable impact damage site 2 and in unsupported skin region. All dimensions are in inches.

Results from strain gages closest to the impact damage site NDT2, (strain gages 43, 44, 45, 46 and 617), and back-to-back strain gages in the unsupported skin region, (strain gages 63 and 64), are shown in figure 62. C-scans of the damaged region made immediately after impact indicate the presence of damage at strain gages 44 and 45, so the structure may not perform as an undamaged structure at these locations. Nonlinear material behavior caused by the impact damage would explain the behavior of gage 45. Strain gages 43 and 46 at the impact damage site show linear behavior at higher loads than strain gages in the unsupported skin region which show linear behavior. The fact that the strain in the unsupported skin region becomes nonlinear before the strain at the impact damage site become nonlinear indicates that the behavior at the impact damage site was not influenced significantly by the buckling of the unsupported skin region.
